UNITED STATES ENVIRONMENTAL PROTECTION AGENCY RCRA Compliance Evaluation Inspection Addendum to 6/18/08 Inspection

Ferro Corporation 251 West Wylie Avenue Washington, PA 15301

Date of Inspection: 10/29/08

RCRA Identification Number: PAD041731670

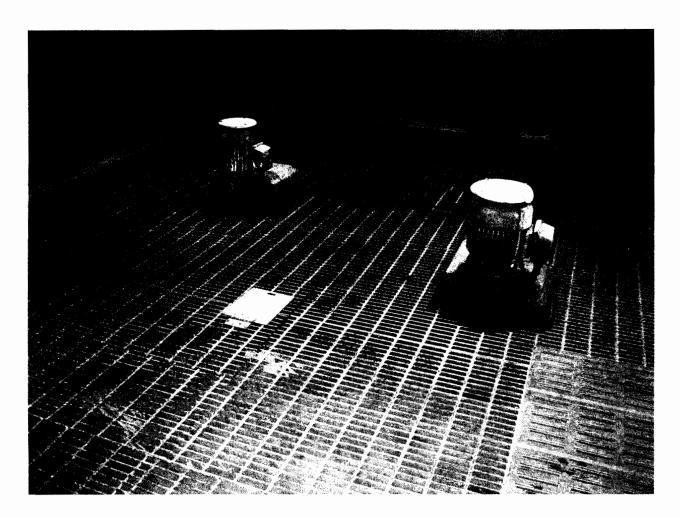
Photo #: 1

This photo depicts tanks #2 & #3.

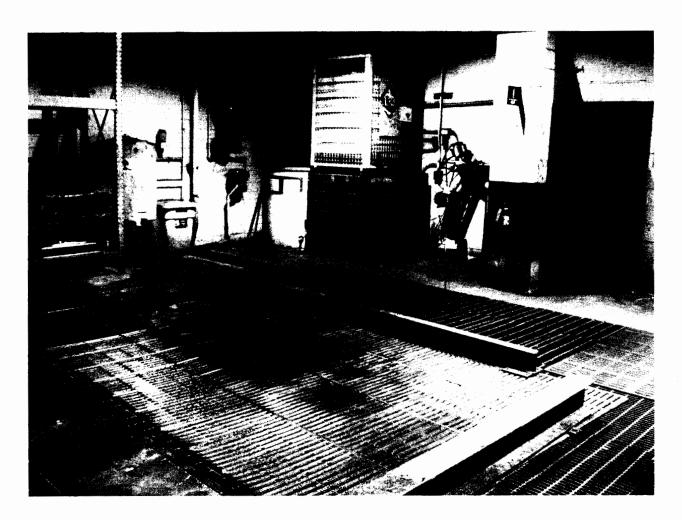
Photo #: 2

This photo depicts tank #1.

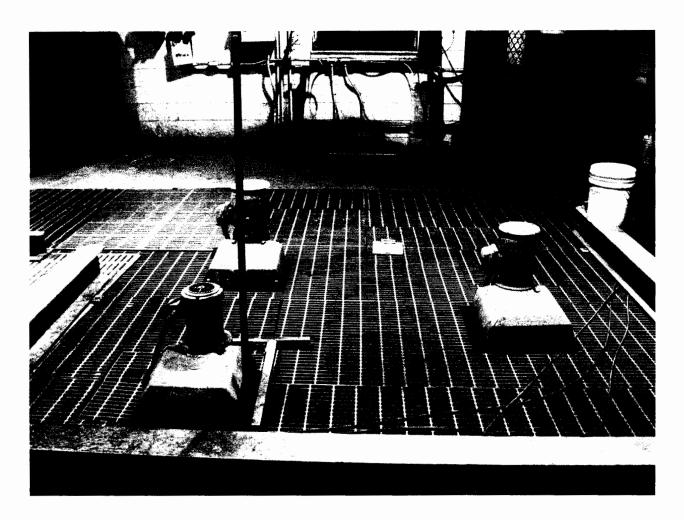
Photo #: 3

This photo depicts tank #2 in the foreground.
